# Operating Experience Weekly Summary 97-49

*November 28 through December 4, 1997*

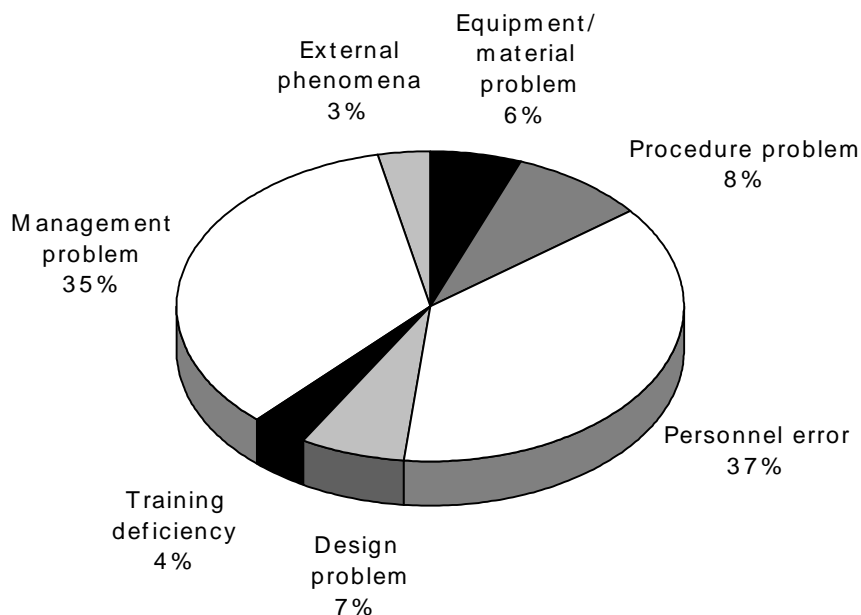
### Figure 1-2. Root Causes for Occupational Illness and Injuries<sup>1</sup>

OEAF engineers searched the ORPS database for events with a nature of occurrence of occupational illness and injuries and found 572 events. Figure 1-2 shows the root causes for these events. A review of these occurrences shows that managers reported 37 percent of the root causes as personnel error, of which 43 percent are attributed to inattention to detail. In addition, they reported 35 percent of the root causes as management problems with 28 percent attributed to inadequate administrative control and 21 percent attributed to work planning deficiency.

<sup>1</sup> OEAF engineers searched the ORPS database using the graphical user interface for reports with a nature of occurrence code of "3A" (occupational illness and injuries) and found 572 events. Based on a random sampling of 200 events, OEAF engineers determined that each slice is accurate to within 0.4 percent.

Facility managers responsible for determining the boundaries of work zones must have a thorough understanding of the system being worked on and an understanding of hazard and barrier analysis. The *Hazard and Barrier Analysis Guide*, developed by OEAF, discusses barriers that provide controls over hazards associated with a job. Barriers may be physical barriers, procedural or administrative barriers, or human action. The reliability of barriers is important in preventing undesirable events such as acid burns. The reliability of a barrier is determined by its ability to resist failure. Barriers can be imposed in series to provide defense-in-depth and to increase the margin of safety. The *Hazard and Barrier Analysis Guide* provides a detailed analysis for selecting optimum barriers, including a matrix that displays the effectiveness of different barriers in protecting against some common hazards.
